**Subject: Removal Action Report  
Community Laundromat Site, Ava, Missouri  
EPA Region 7, START Contract No. EP-S7-13-06, Task Order No. 0200  
Task Monitor: Megan Schuette, On-Scene Coordinator**

**REMOVAL ACTION REPORT**

**COMMUNITY LAUNDROMAT SITE**

**AVA, MISSOURI**

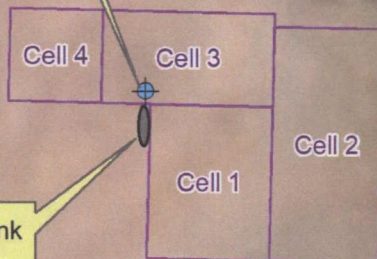
Monitoring Well DNRCL02  
(removed)

Unearthed Tank  
(removed)

Site Building

Concrete  
Pad

Near the northwest corner of Cell 1, adjacent to the cell (see Figure 4), a metal tank was unearthed as excavation of the cell proceeded below the initial 7-foot depth. A hole was created by the excavator, and liquid was expelled from the tank. Flow of that odorous (strong mercaptan-like) liquid into Cell 1 was contained with a berm made from excavated soil. The hole was patched with weld putty, but other leaks were observed, so the tank was not moved from the excavation until the liquid could be removed from it. Three 275-gallon poly totes were delivered to the site into which the liquid would be pumped from the tank following extraction of the tank from the excavation.

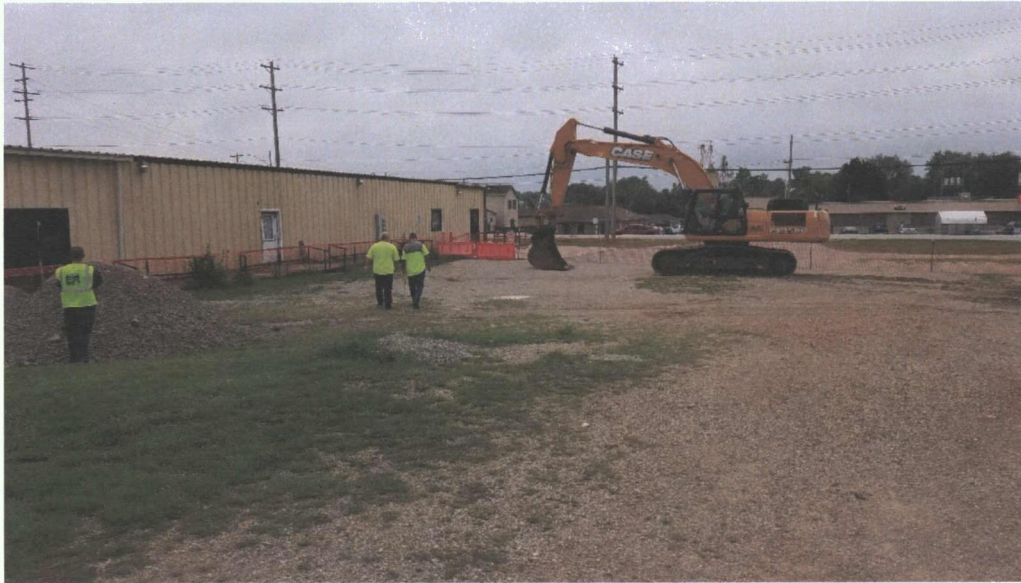
TETRA TECH PROJECT NO. X9025.18.0200.000	DESCRIPTION	This photograph shows the excavation area prior to beginning of excavating activities.	1
	CLIENT	Environmental Protection Agency - Region 7	DATE 8/21/18
	PHOTOGRAPHER	Michelle Handley

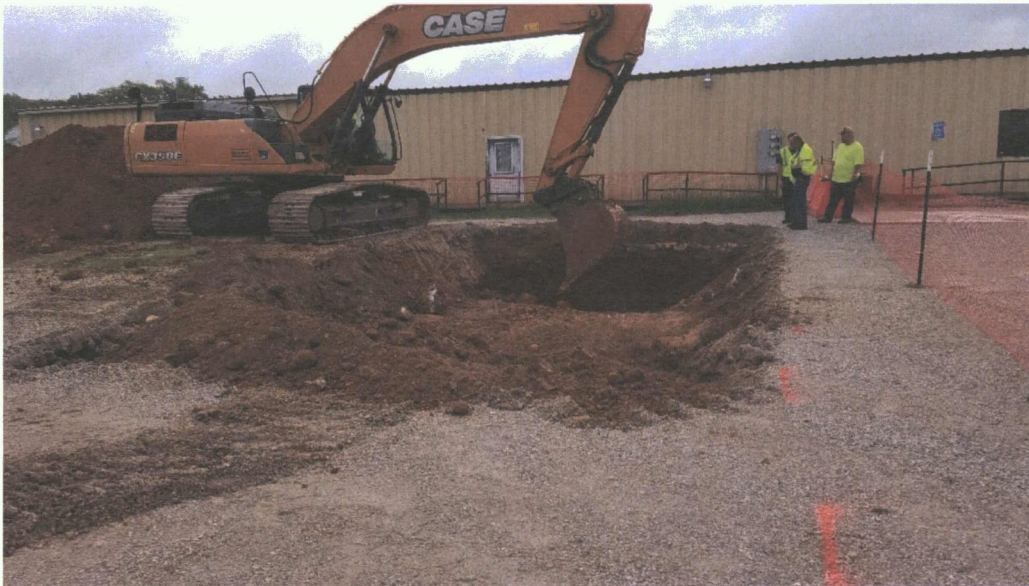
TETRA TECH PROJECT NO. X9025.18.0200.000	DESCRIPTION	This photograph shows excavation Cell 1.	2
	CLIENT	Environmental Protection Agency - Region 7	DATE 8/21/18
	PHOTOGRAPHER	Michelle Handley

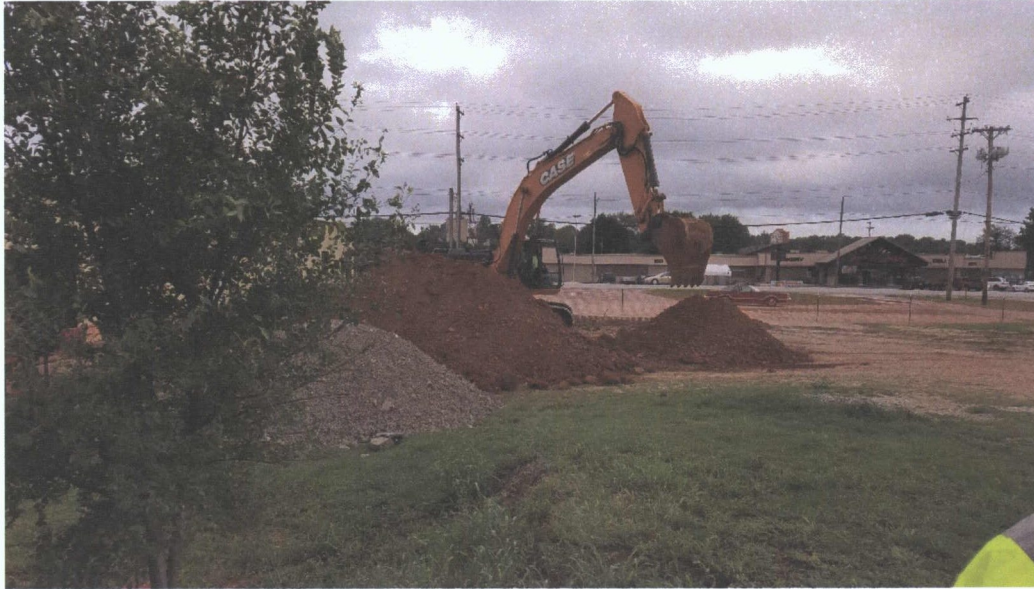
TETRA TECH PROJECT NO. X9025.18.0200.000	DESCRIPTION	This photograph shows excavated soil piles cleared for backfill.	3
	CLIENT	Environmental Protection Agency - Region 7	DATE 04/04/18
	PHOTOGRAPHER	Michelle Handley

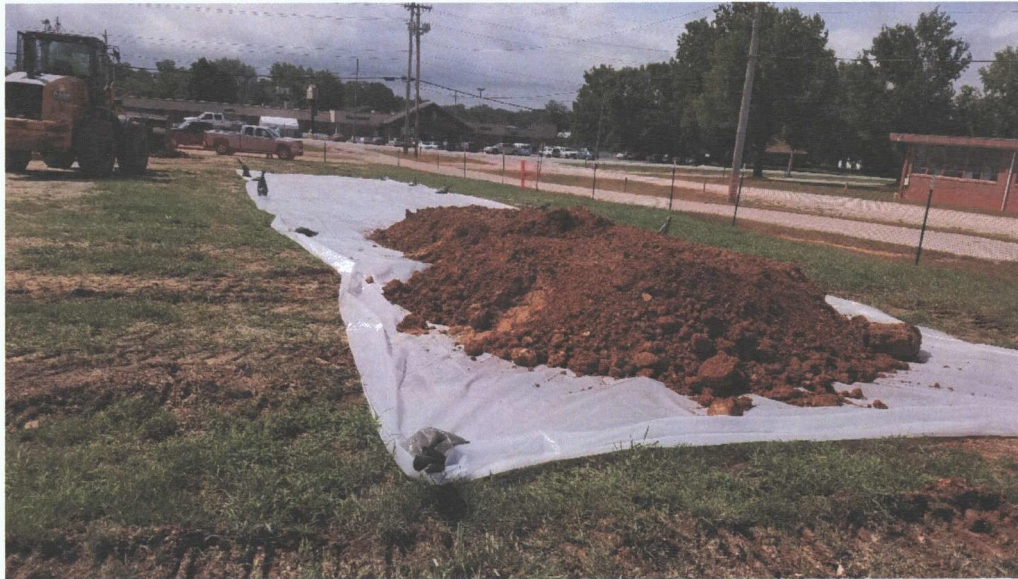
TETRA TECH PROJECT NO. X9025.18.0200.000	DESCRIPTION	This photograph shows disposal pile staging area.	4
	CLIENT	Environmental Protection Agency - Region 7	DATE 8/21/18
	PHOTOGRAPHER	Michelle Handley

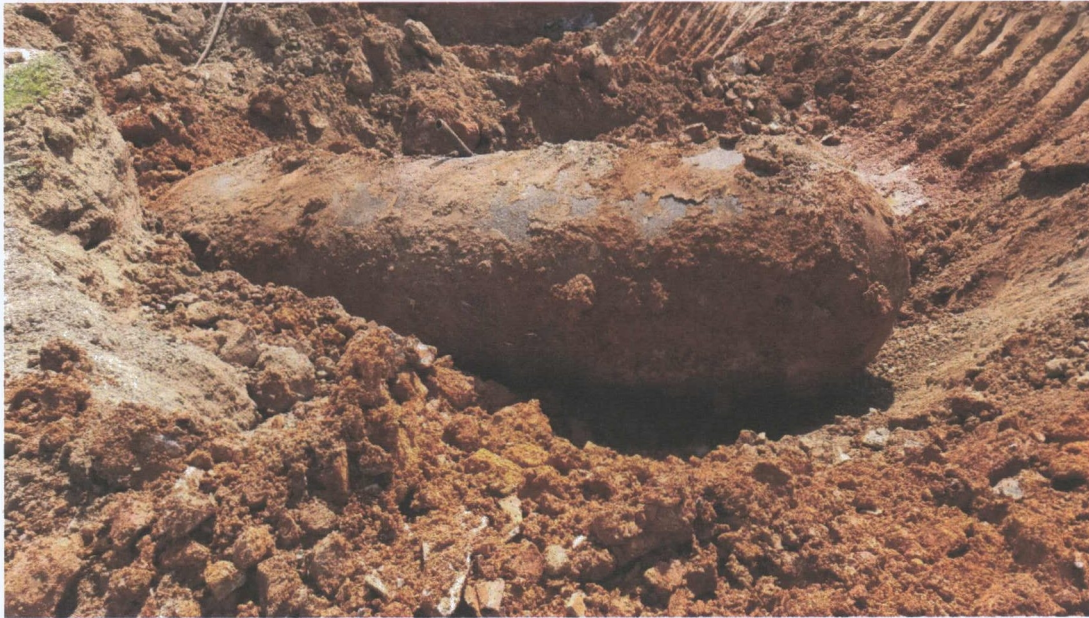
TETRA TECH PROJECT NO. X9025.18.0200.000	DESCRIPTION	This photograph shows metal tank that was unearthed during excavation.	5
	CLIENT	Environmental Protection Agency - Region 7	DATE 8/21/18
	PHOTOGRAPHER	Michelle Handley

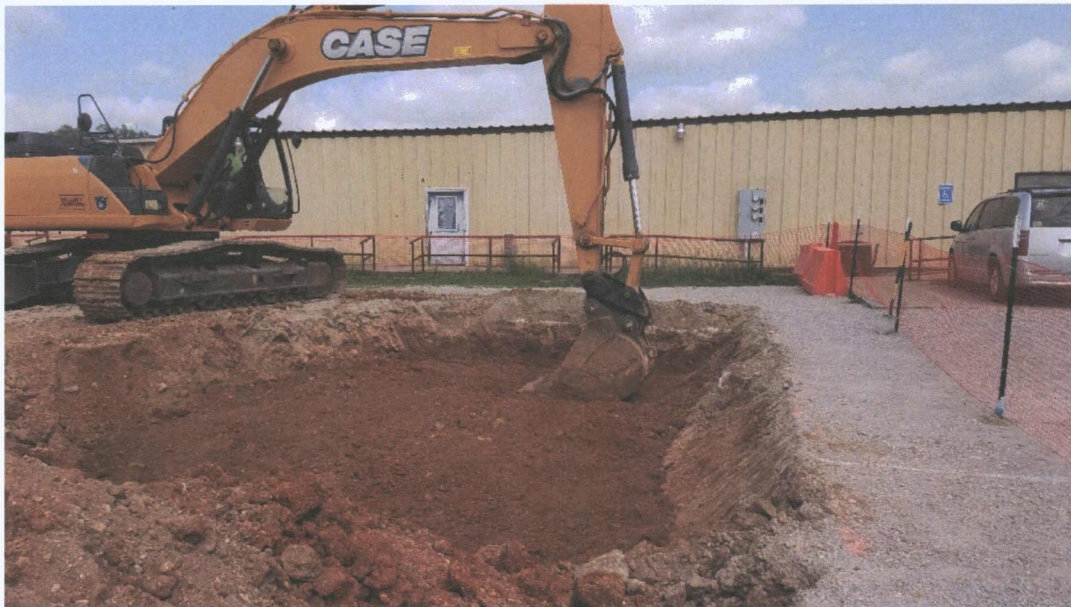
TETRA TECH PROJECT NO. X9025.18.0200.000	DESCRIPTION	This photograph shows backfill of excavation Cell 1.	6
	CLIENT	Environmental Protection Agency - Region 7	DATE 8/21/18
	PHOTOGRAPHER	Michelle Handley

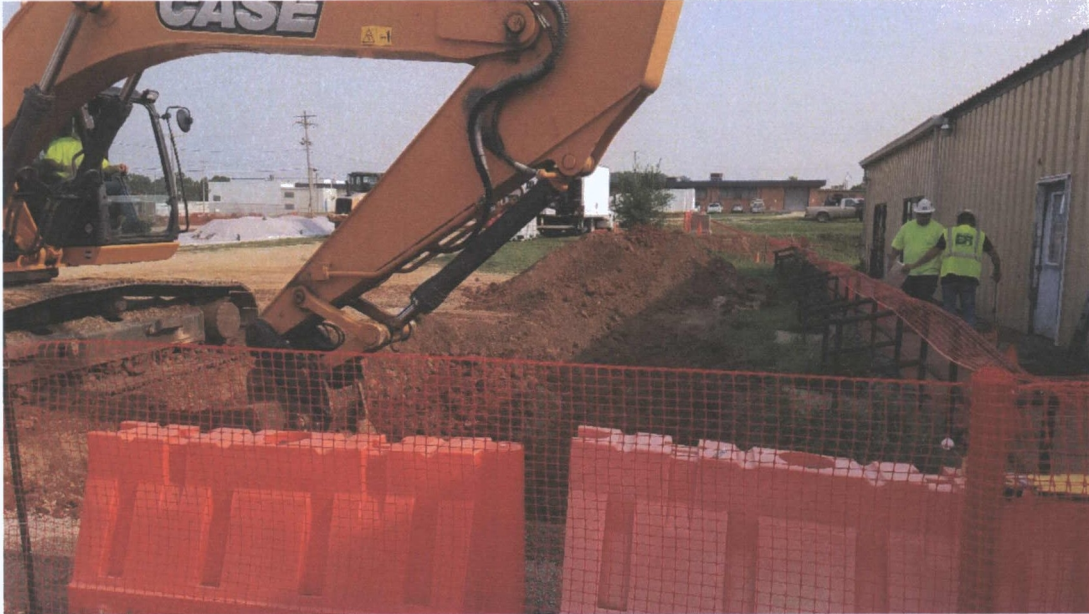
TETRA TECH PROJECT NO. X9025.18.0200.000	DESCRIPTION	This photograph shows excavation of Cell 2.	7
	CLIENT	Environmental Protection Agency - Region 7	DATE 8/22/18
	PHOTOGRAPHER	Michelle Handley

August 22, 2018: City utility workers removed the underground electric line crossing Cell 2 before excavation began there. PID screening identified no OV's in the soil excavated to 8 feet bgs; this soil was set aside for use as backfill. Elevated PID readings from soil within 8 to 13 feet bgs were observed, and this interval of soil was placed on the disposal pile. Excavation of soil in Cell 2 continued to 14 feet bgs; cell area was 18 by 38 feet. OV's were not detected by the PID in soil samples from side walls of Cell 2, except for the east wall where no additional soil could be removed due to close proximity of the on-site building. The clean soil that had been set aside was used to backfill Cell 2.

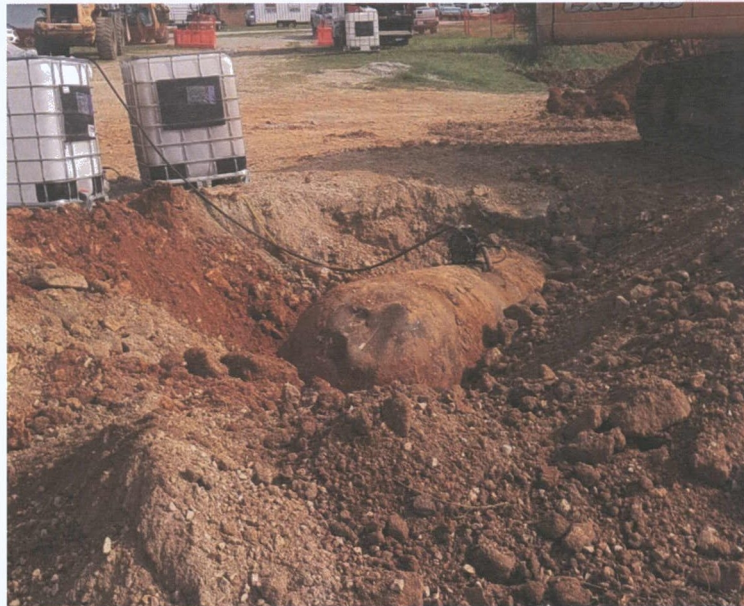
TETRA TECH PROJECT NO. X9025.18.0200.000	DESCRIPTION	This photograph shows unearthed metal tank being pumped out.	8
	CLIENT	Environmental Protection Agency - Region 7	DATE 8/22/18
	PHOTOGRAPHER	Michelle Handley

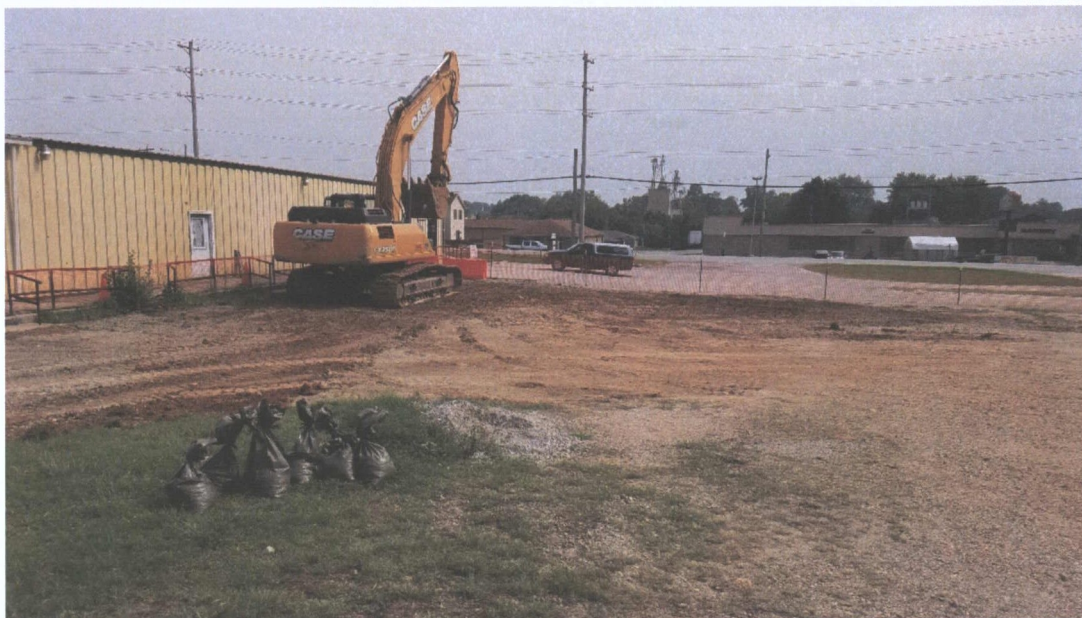
TETRA TECH PROJECT NO. X9025.18.0200.000	DESCRIPTION	This photograph shows backfill of excavation Cell 2.	9
	CLIENT	Environmental Protection Agency - Region 7	DATE 8/22/18
	PHOTOGRAPHER	Michelle Handley

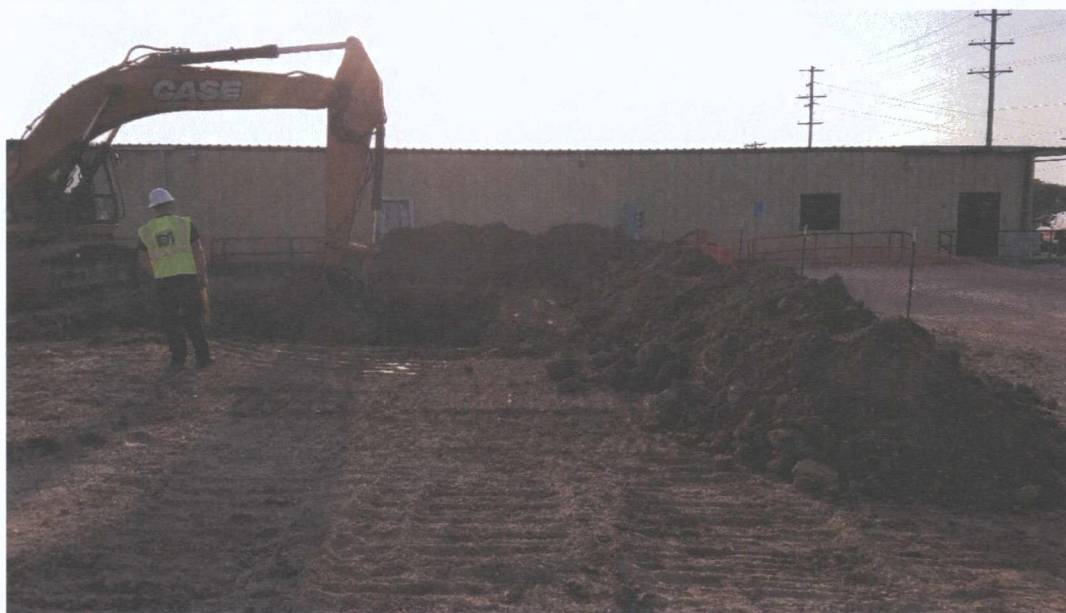
TETRA TECH PROJECT NO. X9025.18.0200.000	DESCRIPTION	This photograph shows excavation of Cell 3.	10
	CLIENT	Environmental Protection Agency - Region 7	DATE 8/23/18
	PHOTOGRAPHER	Michelle Handley

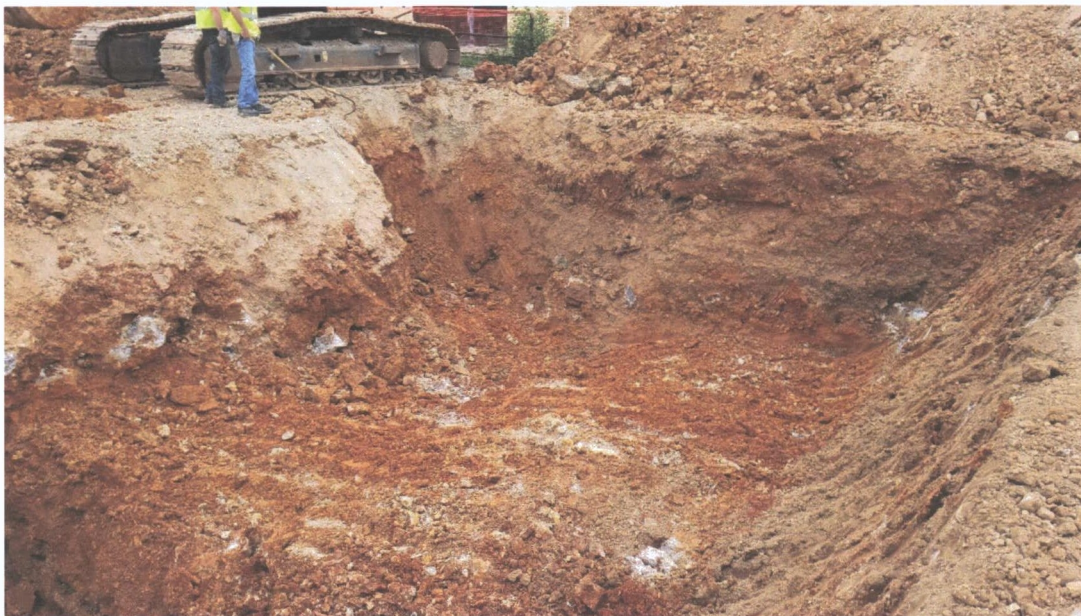
TETRA TECH PROJECT NO. X9025.18.0200.000	DESCRIPTION	This photograph shows entirety of excavation Cell 2.	11
	CLIENT	Environmental Protection Agency - Region 7	DATE 8/23/18
	PHOTOGRAPHER	Michelle Handley

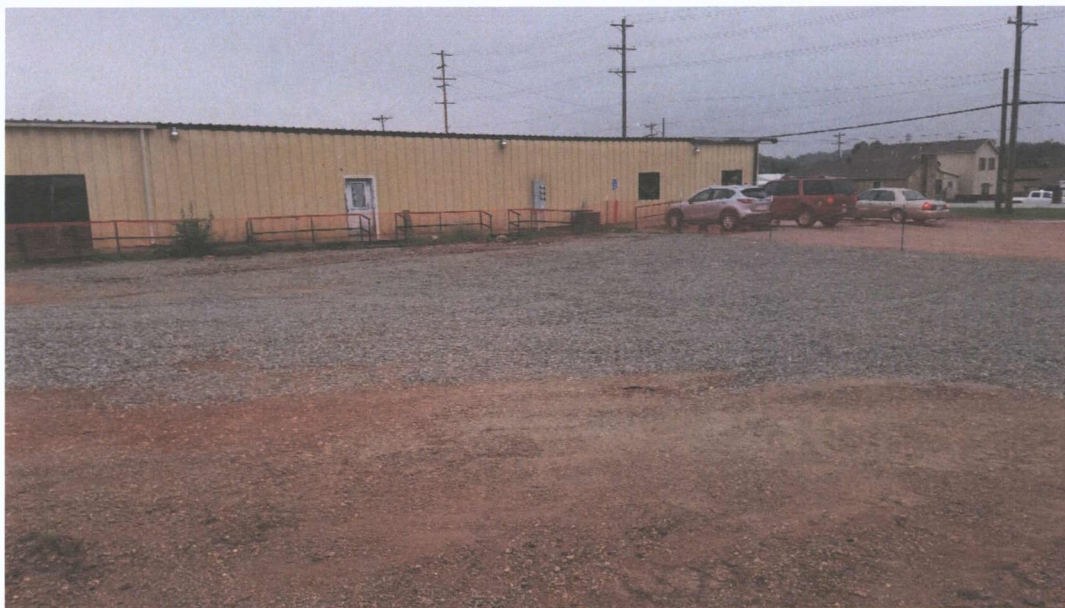
TETRA TECH PROJECT NO. X9025.18.0200.000	DESCRIPTION	This photograph shows excavation area backfilled, graded, and topped with gravel.	12
	CLIENT	Environmental Protection Agency - Region 7	DATE 8/30/18
	PHOTOGRAPHER	Michelle Handley

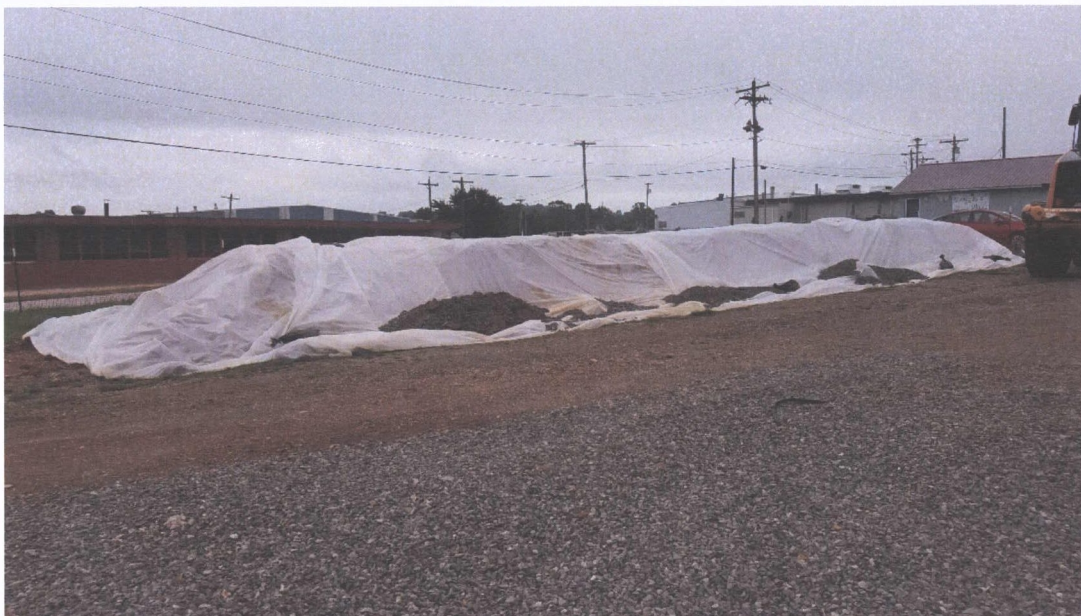
TETRA TECH PROJECT NO. X9025.18.0200.000	DESCRIPTION	This photograph shows entirety of disposal pile.	13
	CLIENT	Environmental Protection Agency - Region 7	DATE 8/30/18
	PHOTOGRAPHER	Michelle Handley

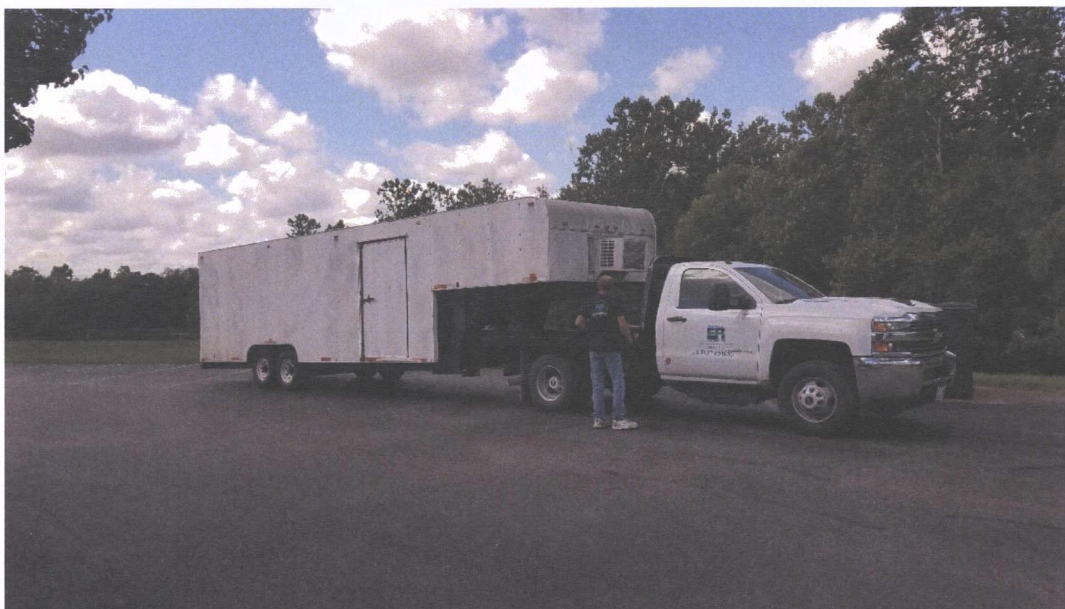
TETRA TECH PROJECT NO. X9025.18.0200.000	DESCRIPTION	This photograph shows groundwater treatment trailer being prepared for transport to scrap yard.	14
	CLIENT	Environmental Protection Agency - Region 7	DATE 9/11/18
	PHOTOGRAPHER	Michelle Handley

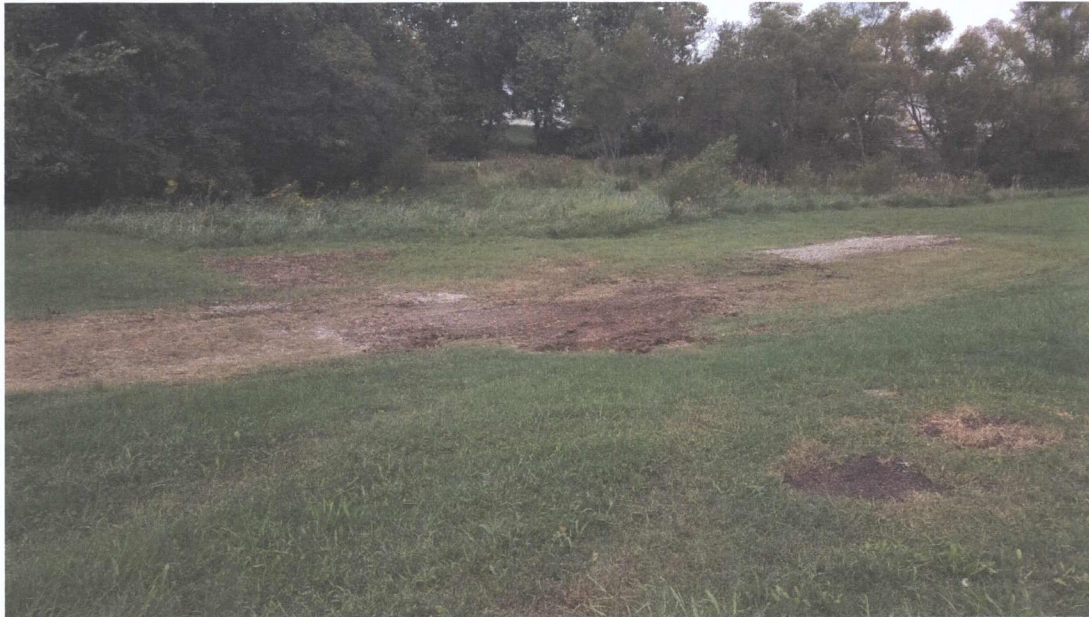
TETRA TECH PROJECT NO. X9025.18.0200.000	DESCRIPTION	This photograph shows area where groundwater treatment trailer was located, having been graded.	15
	CLIENT	Environmental Protection Agency - Region 7	DATE 9/11/18
	PHOTOGRAPHER	Michelle Handley

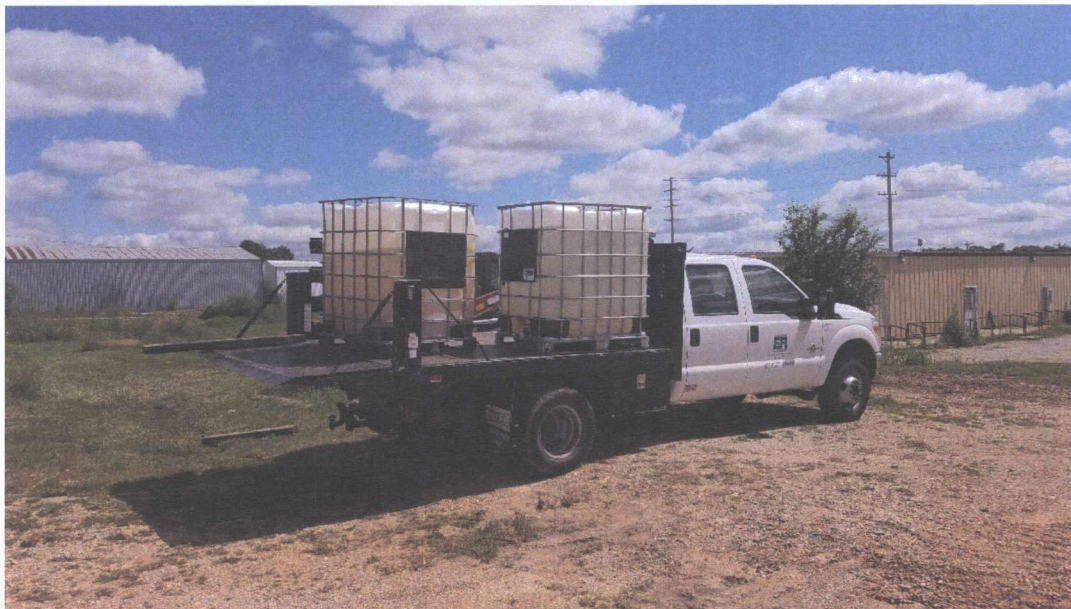
TETRA TECH PROJECT NO. X9025.18.0200.000	DESCRIPTION	This photograph shows liquid waste totes being loaded for transport to disposal facility.	16
	CLIENT	Environmental Protection Agency - Region 7	DATE 9/11/18
	PHOTOGRAPHER	Michelle Handley
